**50 YEARS OF
BLAST VIBRATION
MONITORING & CONTROL**

Deep Dive into RI 8507

8507 Structure Response & Damage Produced by Ground Vibrations from Surface Blasting

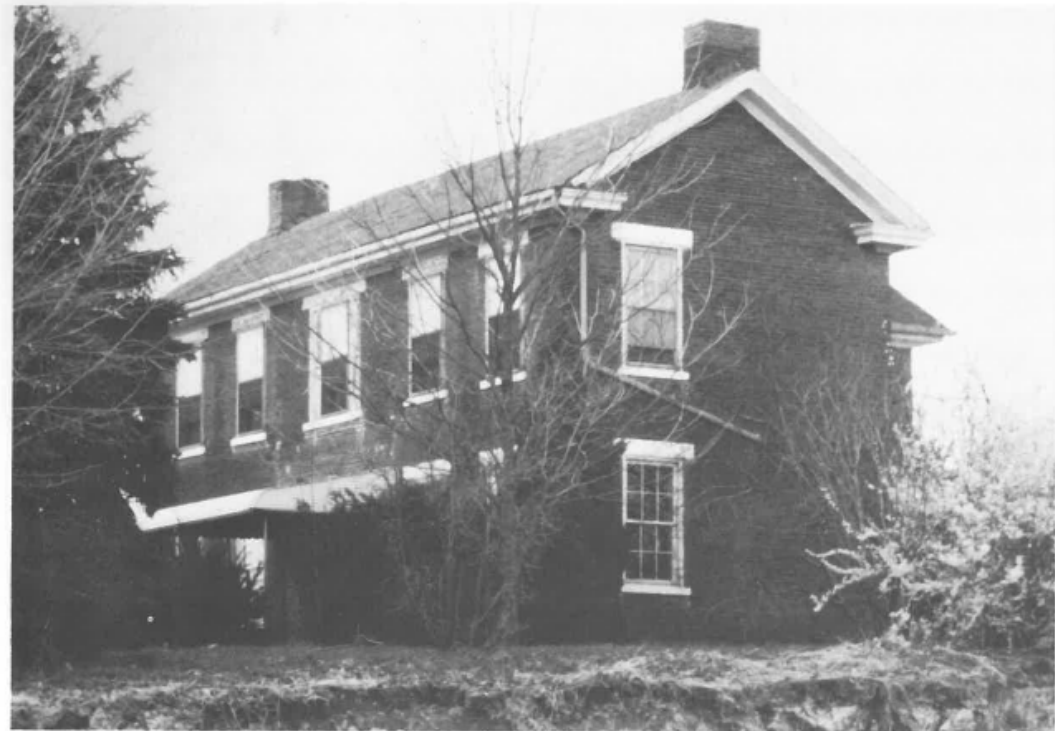
**Structure 51 -
plaster and lath walls
Over abandoned coal mine
wall paper stripped to
expose extensive cracking**

Figure 27.—Test structure 51, near a coal mine.

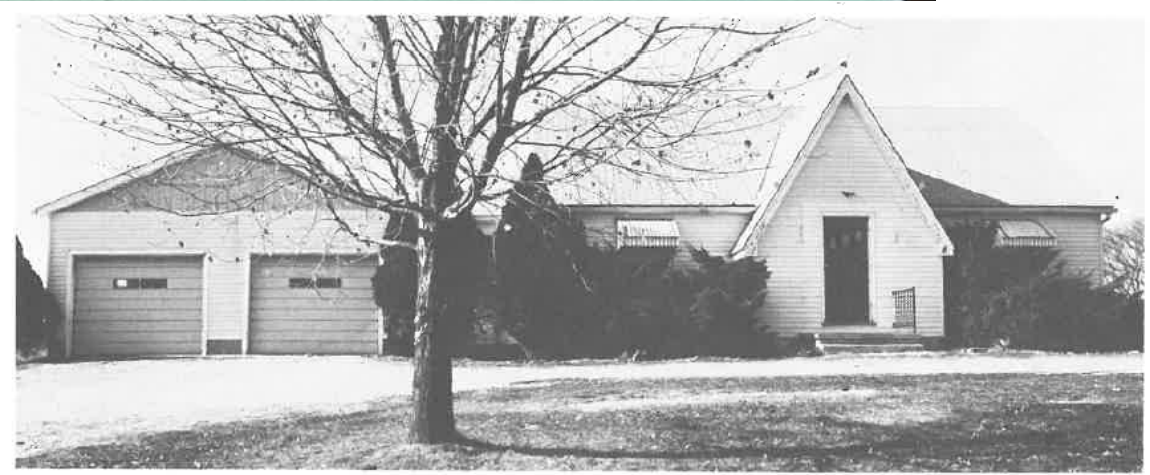
Structure 20

Figure 16.—Test structure 20, near a coal mine.

Structure 20
Newer, Gypsum Wallboard
Lowest PPV = 0.79 ips (20 mm/s)
Threshold Crack

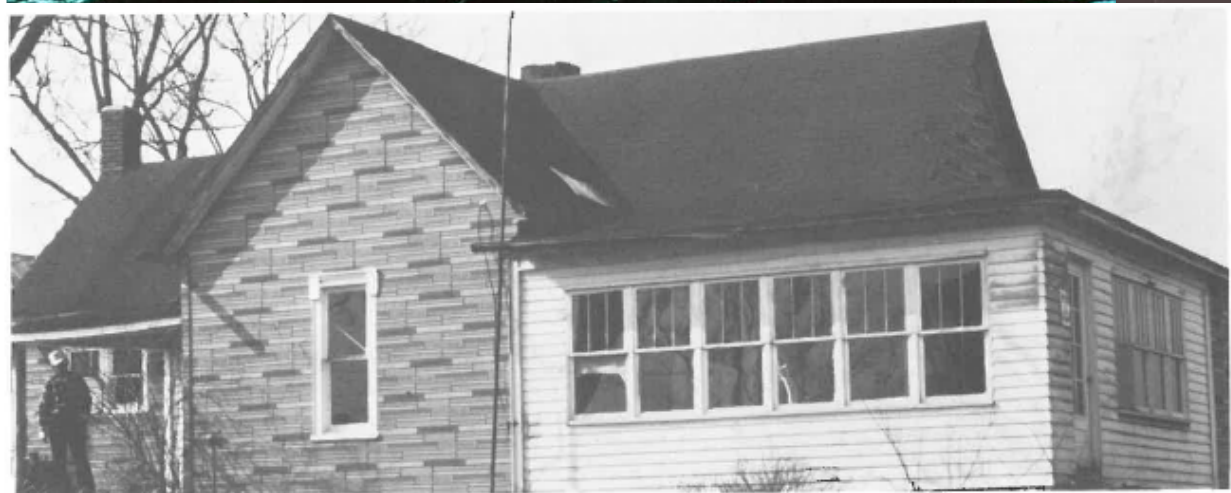
Structure 27
Lowest PPV - 0.72 ips
to produce
cosmetic cracking in
plaster and lath

Figure 21.—Test structure 27, near a coal mine.

Structures 19, 27, 51
Plaster & Lath, Old, Distressed
Old in the late 1970's
Lowest PPV = 0.72 ips (18.2 mm/s)
Threshold Crack

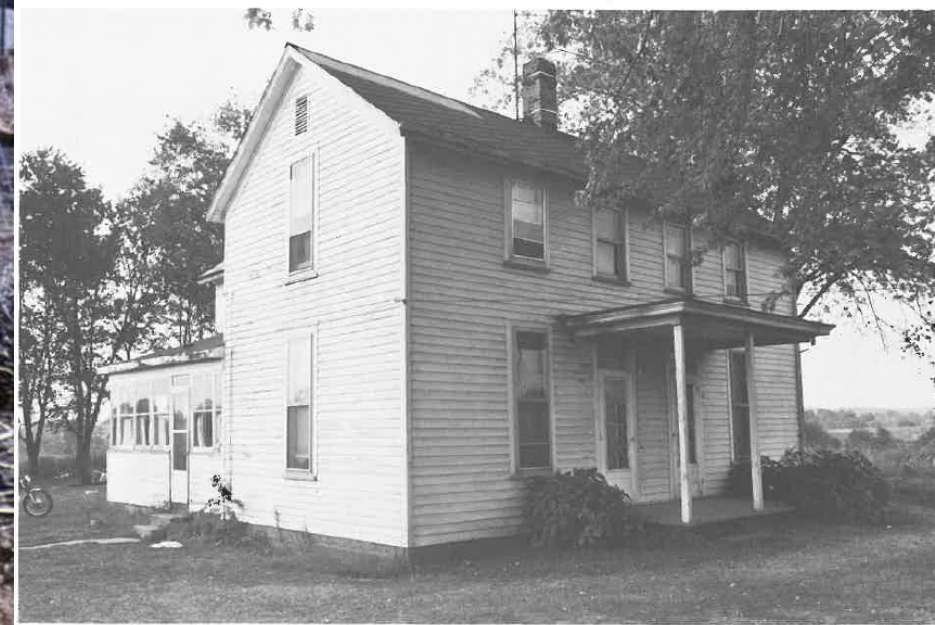
Figure 15.—Test structure 19, near a coal mine.

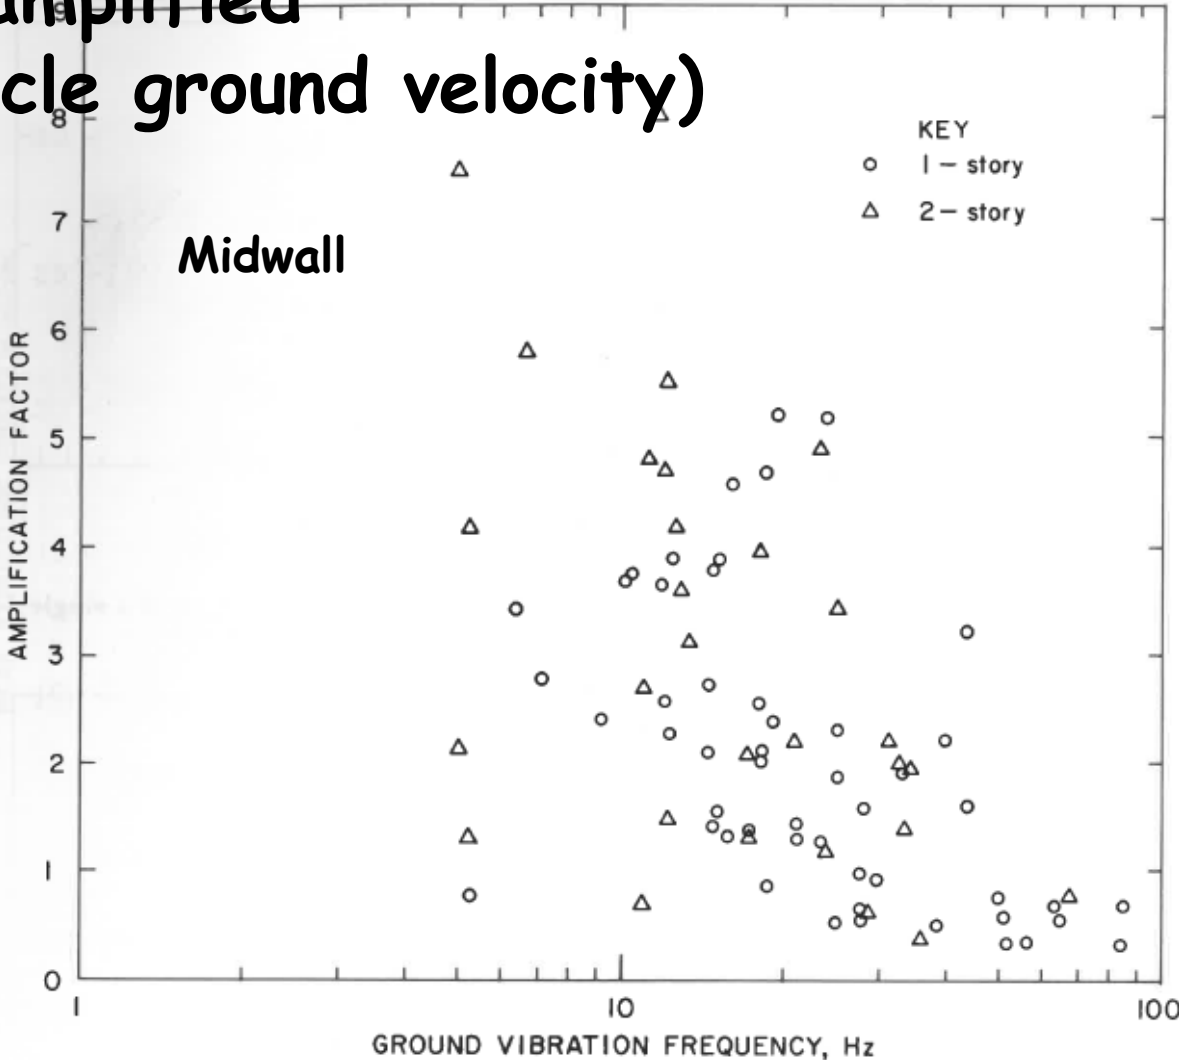
7) Home velocity response was amplified
(eg was greater than peak particle ground velocity)

Figure 39.—Amplification factors for blast-produced structure vibration (corners), all homes.

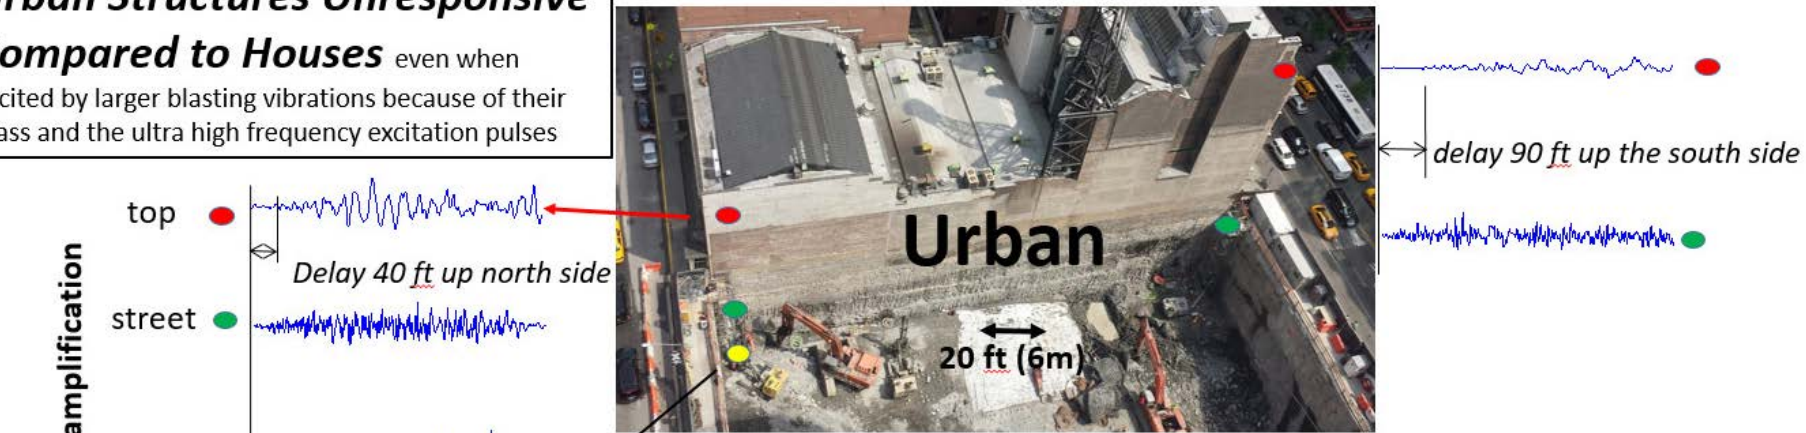
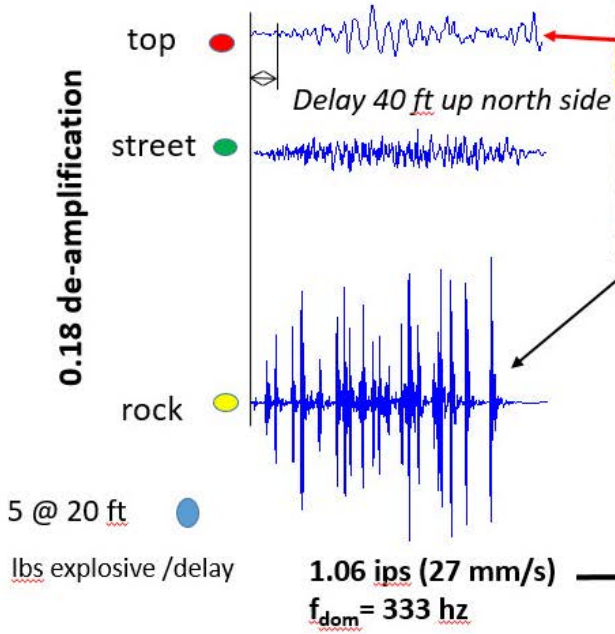
Urban Structures Unresponsive Compared to Houses even when excited by larger blasting vibrations because of their mass and the ultra high frequency excitation pulses

Timing, frequency and amplitudes of motions at various locations around **urban** structure show low, de-amplified response compared to the amplified response of small residential (**house**) structures even though urban excitation

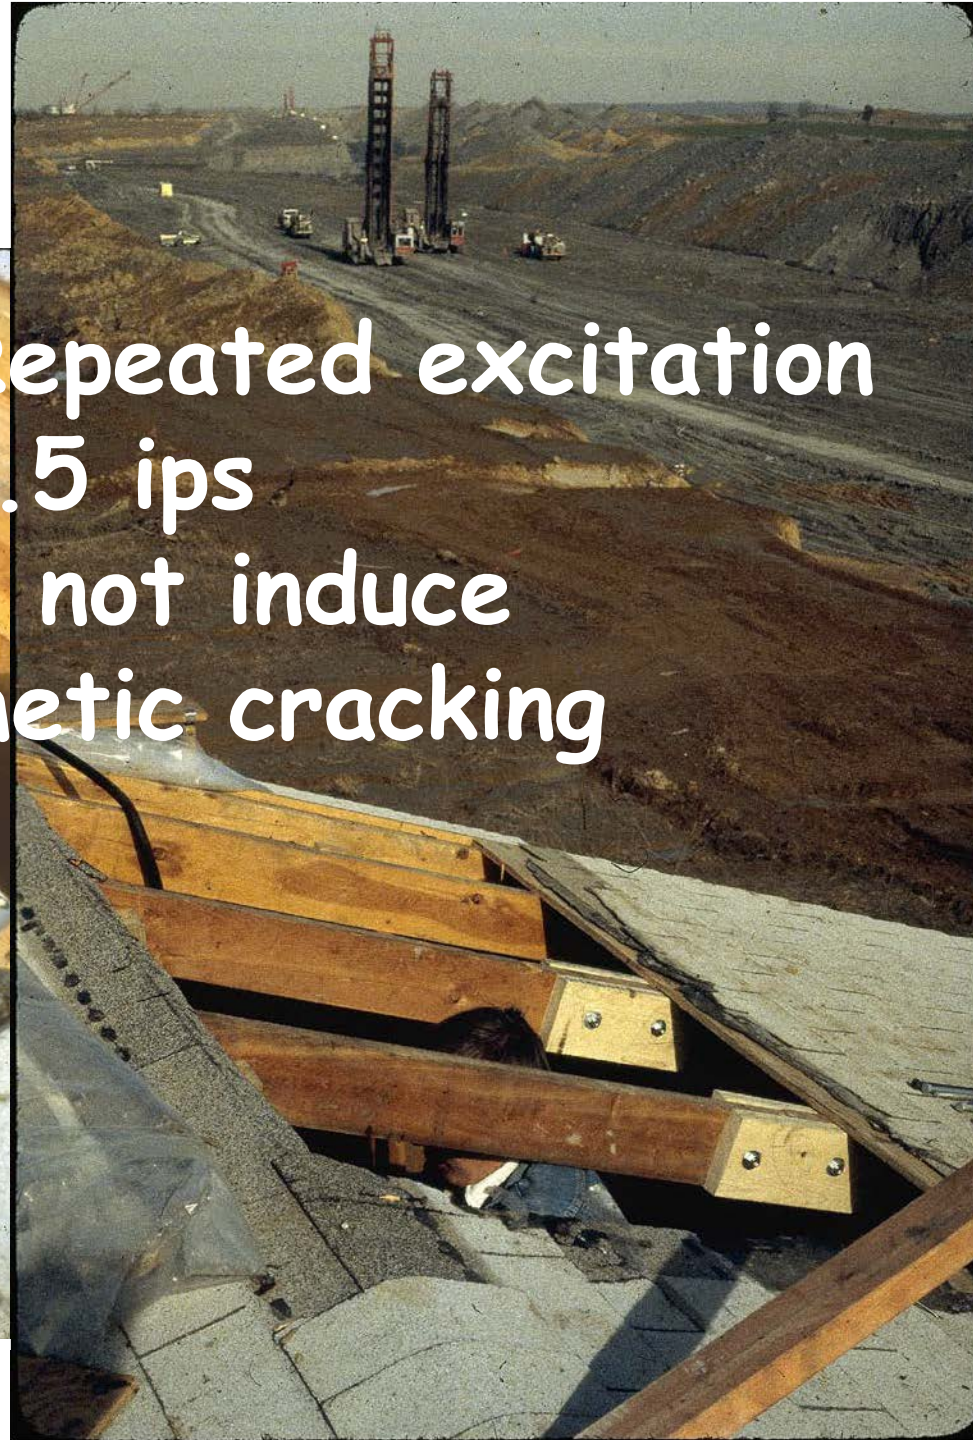
One of two eccentrically weighted rotors to deform entire house

1) Repeated excitation at 0.5 ips does not induce cosmetic cracking
